LABORATORY EVALUATION OF 4-3/4-INCH FLASH-WELDED ALLOY STEEL STUD LINK ANCHOR CHAIN (Report No. NSSC 1-1)

David C. Doerschuk, Robert J. Eiber, and Thomas P. Groeneveld

NAVAL SEA SYSTEMS COMMAND DEPARTMENT OF THE NAVY Washington, D. C. 20362 (MIPR No. NO02476 MP6626M)

August 1977

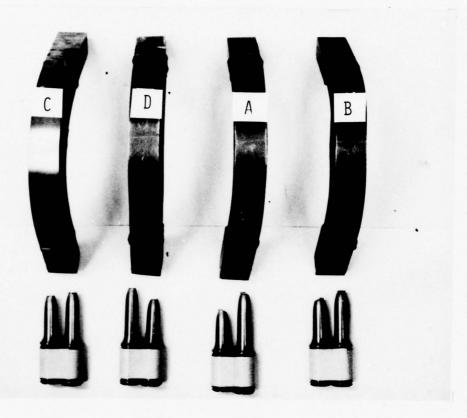
All of the specimens passed the *Interim Specification* bend-test requirement of 120 degrees with no crack. There was some localized yielding evident in the weld region; however, no crack extended across the surface of the specimen. Figure 1 shows the bend specimens after testing.

FIGURE 1. TENSILE SPECIMENS AFTER BEND TESTING

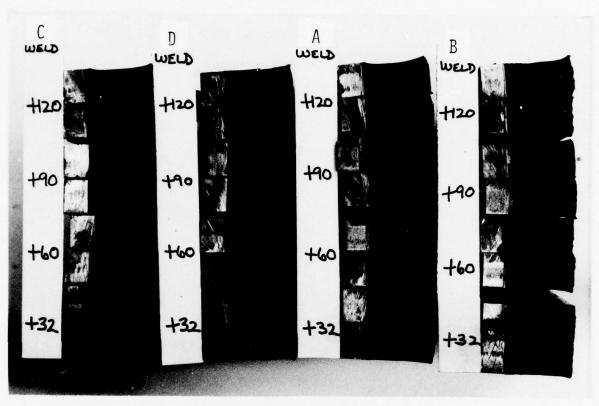
Figures 11 through 14 and 15 through 18 for the flash-welded and base-metal specimens, respectively. Figures 19 and 20 show dynamic tear fracture surfaces for the flash-welded and base-metal specimens, respectively. It can be noted in Figure 20 that several of the base-metal specimens from Samples B and C did not fracture completely at the higher temperatures in the dynamic tear test. This is an indication of the relatively high toughness of the material and is also an indication of the tendency of the material to split in the axial direction of the chain link. (This latter indication is not believed to be of any significance in terms of the performance of the chain link.)

FIGURE 19. DYNAMIC TEAR FRACTURE SURFACES OF FLASH-WELDED SPECIMENS

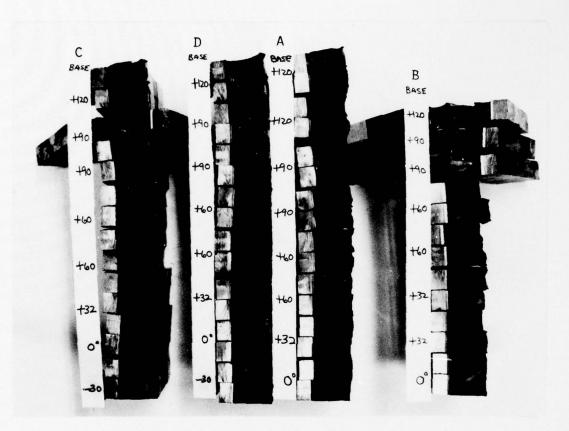
FIGURE 20. DYNAMIC TEAR FRACTURE SURFACES OF BASE-METAL SPECIMENS

Note that some specimens from Samples B and C did not fracture completely at the higher temperatures, indicating the relatively high toughness of the material and tendency to split in the axial direction of the link.

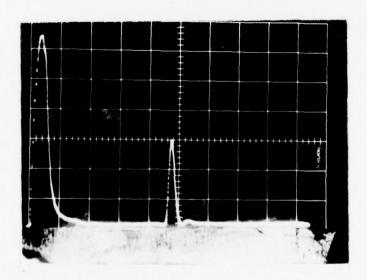
A sketch of the inspected area is shown in Figure 22. At Location 1 there were a large number of indications of various amplitudes. Figure 23 shows the ultrasonic indication obtained at Location 1. Location 2 gave no signals of over 5 percent amplitude. The size of the area at Location 1 was estimated to be 1 by 1 in., which was the largest area giving an ultrasonic indication of any of the chain samples. The inspected piece was later cut up and subjected to dynamic tear testing. No defects were found and high impact energies were obtained.

Location 1 was estimated to be approximately 1 by 1 in. and was the largest area giving an ultrasonic indication of any of the chain samples. Location 2 gave no signals of more than 5 percent amplitude.

FIGURE 23. ULTRASONIC INDICATION AT LOCATION 1, SAMPLE A LINK

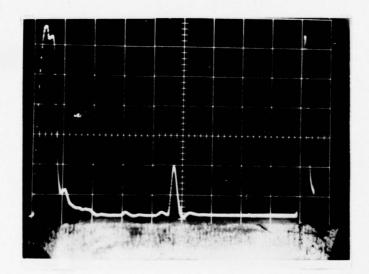
The strongest indication (about 29 percent of maximum) was at Location 1 (estimated area 3/8 by 1/2 in.), Location 2 (estimated area 1/8 by 1/8 in.) and Locations 3 and 4 (estimated area 1/16 by 1/16 in.) gave indications of about 5 percent of maximum.

FIGURE 25. ULTRASONIC INDICATION AT LOCATION 1, SAMPLE B LINK

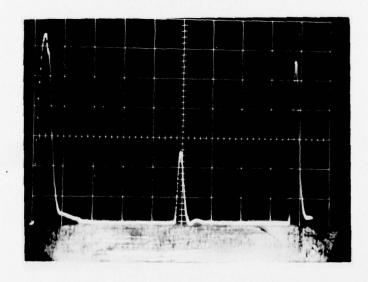
Location 1 showed a large number of indications. Position A (estimated size about 1/2 by 1/2 in.) was the largest. Location 2 showed indications of 5 to 8 percent of maximum or less. This link was also examined using the ultrasonic shearwave technique (see Figures 28 and 29).

FIGURE 27. ULTRASONIC INDICATION AT LOCATION 1, POSITION A, SAMPLE C LINK

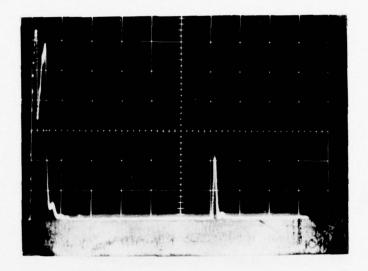
FIGURE 28. SHEAR-WAVE ULTRASONIC INDICATION OF THE 1/8-IN.-DEEP SAWCUT, SAMPLE C LINK

The sawcut was made across the surface of the link as a reference flaw.

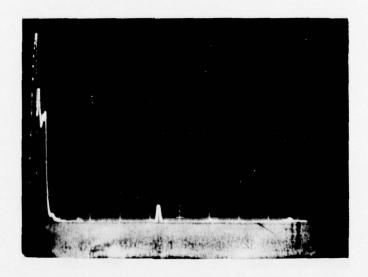
To perform the shear-wave test, a reference flaw was made on the surface. A sawcut 1/8 in. deep was made across the link sample. The ultrasonic indication from the sawcut is shown in Figure 28. The ultrasonic indication of the suspected flaw found at Location 1 is shown in Figure 29.

FIGURE 29. SHEAR-WAVE ULTRASONIC INDICATION OF THE SUSPECTED FLAW AT LOCATION 1, POSITION A, SAMPLE C LINK

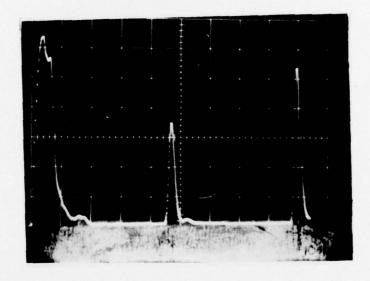
Position A (estimated size 3/4 by 1/2 in.) gave the strongest indication. No other indications over 5 percent were recorded.

FIGURE 31. ULTRASONIC INDICATION AT POSITION A, SAMPLE D LINK

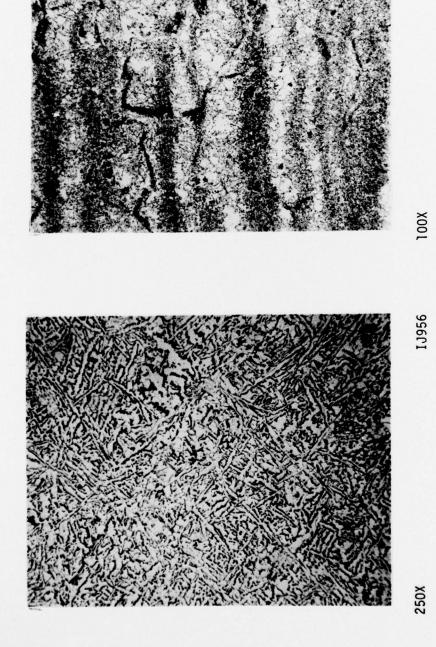
Picral Etch
FIGURE 39. COARSE PRIOR STRUCTURE OUTLINED BY
DARK ETCHING MATERIAL ADJACENT TO
FUSION ZONE IN LINK FROM SAMPLE D

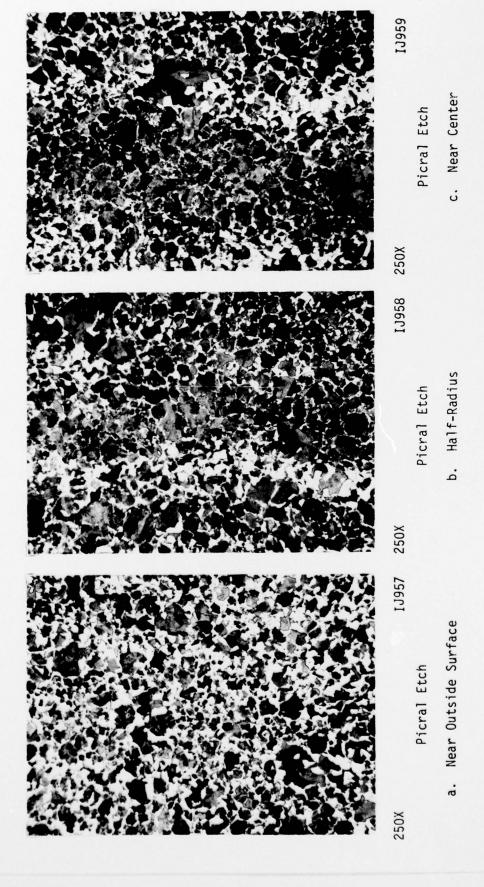
Link from Sample A. The microstructural variations from the outside surface to the center of the link from Sample A are illustrated in Figure 40. Near the outside surface, the microstructure consisted of a mixture of black ferrite and pearlite with little banding. As the distance from the outside surface increase, the banding of the microstructure became more apparent.

FIGURE 40. VARIATION IN MICROSTRUCTURE FROM OUTSIDE SURFACE TO CENTER OF LINK FROM SAMPLE A

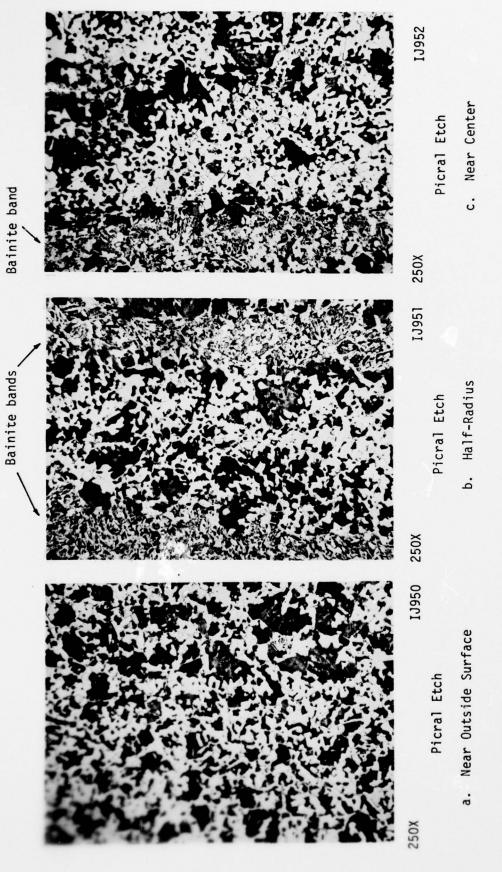
Link from Sample B. The variation in microstructure from the outside surface to the center of the link from Sample B is illustrated in Figure 41. Near the outside surface, the microstructure consisted of a mixture of ferrite and pearlite with little evidence of banding. As the distance from the outside surface increased, the degree of banding increased. In addition, at about the midradius position and toward the center of the link, there were bands with a bainitic structure. The presence of the bainitic structure indicates that the steel in those bands had higher hardenability, presumably because of higher carbon and manganese contents, than that of the adjacent material.

FIGURE 41. VARIATION IN MICROSTRUCTURE FROM OUTSIDE SURFACE TO CENTER OF LINK FROM SAMPLE B

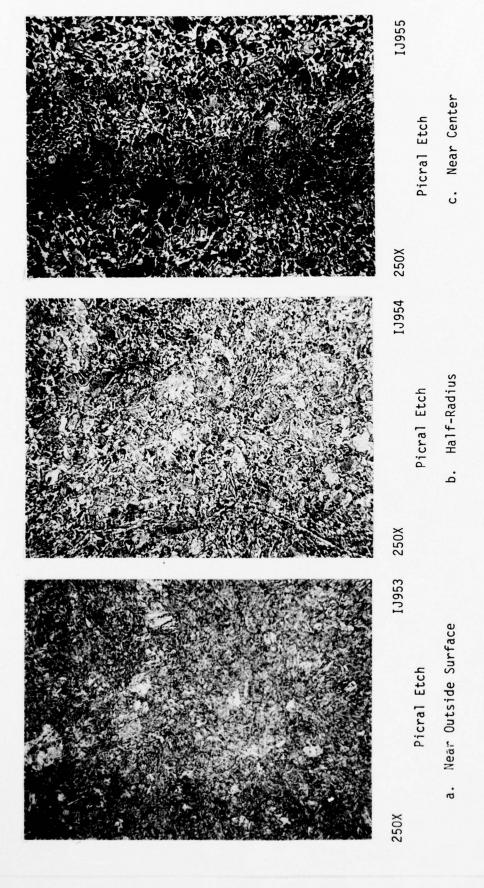
Link from Sample C. The variation in microstructure from the outside surface to the center of this link is illustrated in Figure 42. Near the outside surface, the microstructure consisted of tempered martensite. As the distance from the surface increased, the amounts of higher temperature transformation products (ferrite and pearlite) increased because of the lower cooling rates at those locations. Near the center of the link, the microstructure was banded and consisted of a mixture of ferrite and pearlite.

Since the hardenability of the steel is such that it would not be expected to air harden in these large sections at the cooling rates normally expected from a normalizing treatment, the martensitic structure observed in the link from the chain sample indicates that the steel was austenitized, quenched, and tempered after welding. Thus, it would not meet the requirement of the Interim Specification for the steel to be normalized after welding (Paragraph 3.13.5).

FIGURE 42. VARIATION IN MICROSTRUCTURE FROM OUTSIDE SURFACE TO CENTER OF LINK FROM SAMPLE C

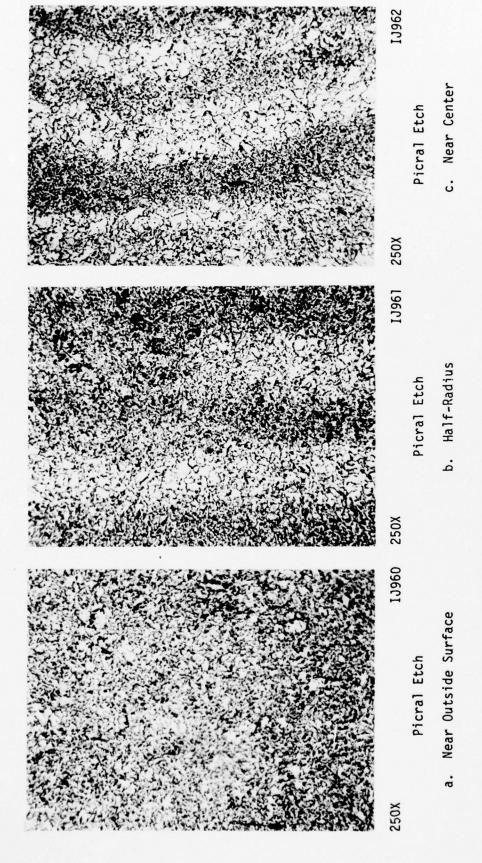
Link from Sample D. The microstructural variations from the outside surface to the center of the link from Sample D are illustrated in Figure 43. The microstructure near the outside surface was fine grained and consisted of a mixture of ferrite and pearlite; there was little banding evident in that region.

As the distance from the outside surface increased, the amount of microstructural banding increased. The carbides in the microstructure of this steel were partially spheroidized, a condition that indicates that the steel had been tempered after normalizing.

FIGURE 43. VARIATION IN MICROSTRUCTURE FROM OUTSIDE SURFACE TO CENTER OF LINK FROM SAMPLE D
